DEPARTMENT OF TRANSPORTATION**DIVISION OF ENGINEERING SERVICES**

Contract #: 04-0120F4Cty: SF/ALA Rte: 80 PM: 13.2/13.9File #: 1.28**WELDING INSPECTION REPORT****Resident Engineer:**Pursell, Gary**Address:** 333 Burma Road**City:** Oakland, CA 94607**Report No:** WIR-014308**Date Inspected:** 20-May-2010**Project Name:** SAS Superstructure**OSM Arrival Time:** 630**Prime Contractor:** American Bridge/Fluor Enterprises, a JV**OSM Departure Time:** 1500**Contractor:** American Bridge/Fluor Enterprises, a JV**Location:** Job Site

Summary of Items Observed:

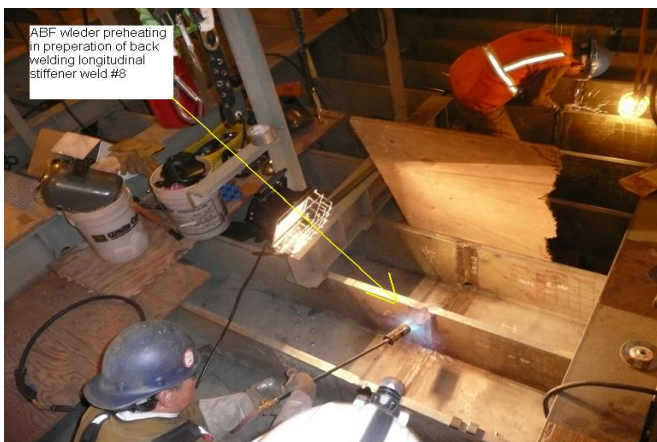
The QA Inspector randomly observed the SE QC Inspector identified as Steve McConnell begin performing Ultrasonic Testing (UT) of the previously completed weld. The QA Inspector did not observe the QC Inspector locate any rejectable weld defects on the QA Inspectors shift.
